Heat Source, Flammable Liquid and Combustible Material

Lawrence Berkeley National Laboratory Lessons Learned

LL-2005-01

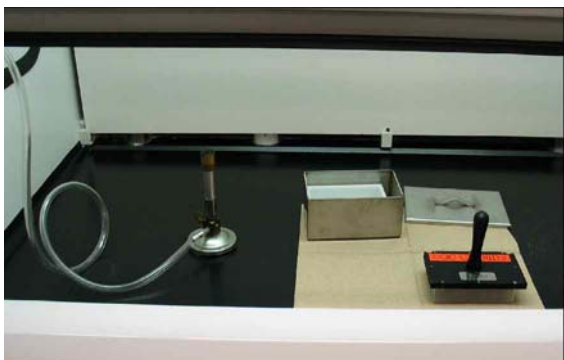
Incident: A lab employee was working in the fume hood stamping 384-well glycerol stock plates. The purpose of this activity was to perform additional QC checks of glycerol stock plates. The process uses a Bunsen burner, hand-held 384 pin-stamping tool, small bath of 100% ethanol, glycerol stock plates, and bioassay plates. After submerging the stamping tool into the ethanol bath, the employee passed the pins over the open flame. A droplet of ethanol fell onto a paper towel placed under the plates. The paper towel and ethanol bath caught fire and began to burn. The supervisor whose office is adjacent to the lab was immediately notified, and he extinguished the small fire with an ABC fire extinguisher. There was no injury to the employee, smoke inhalation to the lab workers, or damage to the fume hood.

Cause: The set-up protocol did not call for paper towels to be placed under the ethanol bath. As a measure to improve laboratory hygiene, the employee decided to place the combustible paper towel underneath the plastic ethanol bath and hand-held stamping tool. Employee may also have saturated the pins and did not tap the stamping tool lightly against the side of the bath to remove all the excess ethanol.

- ❑ The employee has been reminded not to deviate from the protocol; it was also re-emphasized that no combustible paper towels are to be placed underneath the ethanol bath.
- ❑ The hand-held stamping pin was tested to determine if it was a defective device. Tests were negative. Attempts to re-enact dripping ethanol dripping from the pins after being saturate could not be duplicated. It was placed back in service.
- ❑ The lid shown in the picture was not immediately accessible. The presence of this lid would have made extinguishing the flame much easier. The operators have been trained to have the lid immediately available and this has been added to the operator protocol for the procedure and has been identified as an area for additional training.
